Corrosion Report

Equipment Location ID 0955-002-022
Equip. Location Descrip. V-1103 VAPOR TO C-1100

History Brief

For Location ID: 0955-002-022 in Unit: 0955

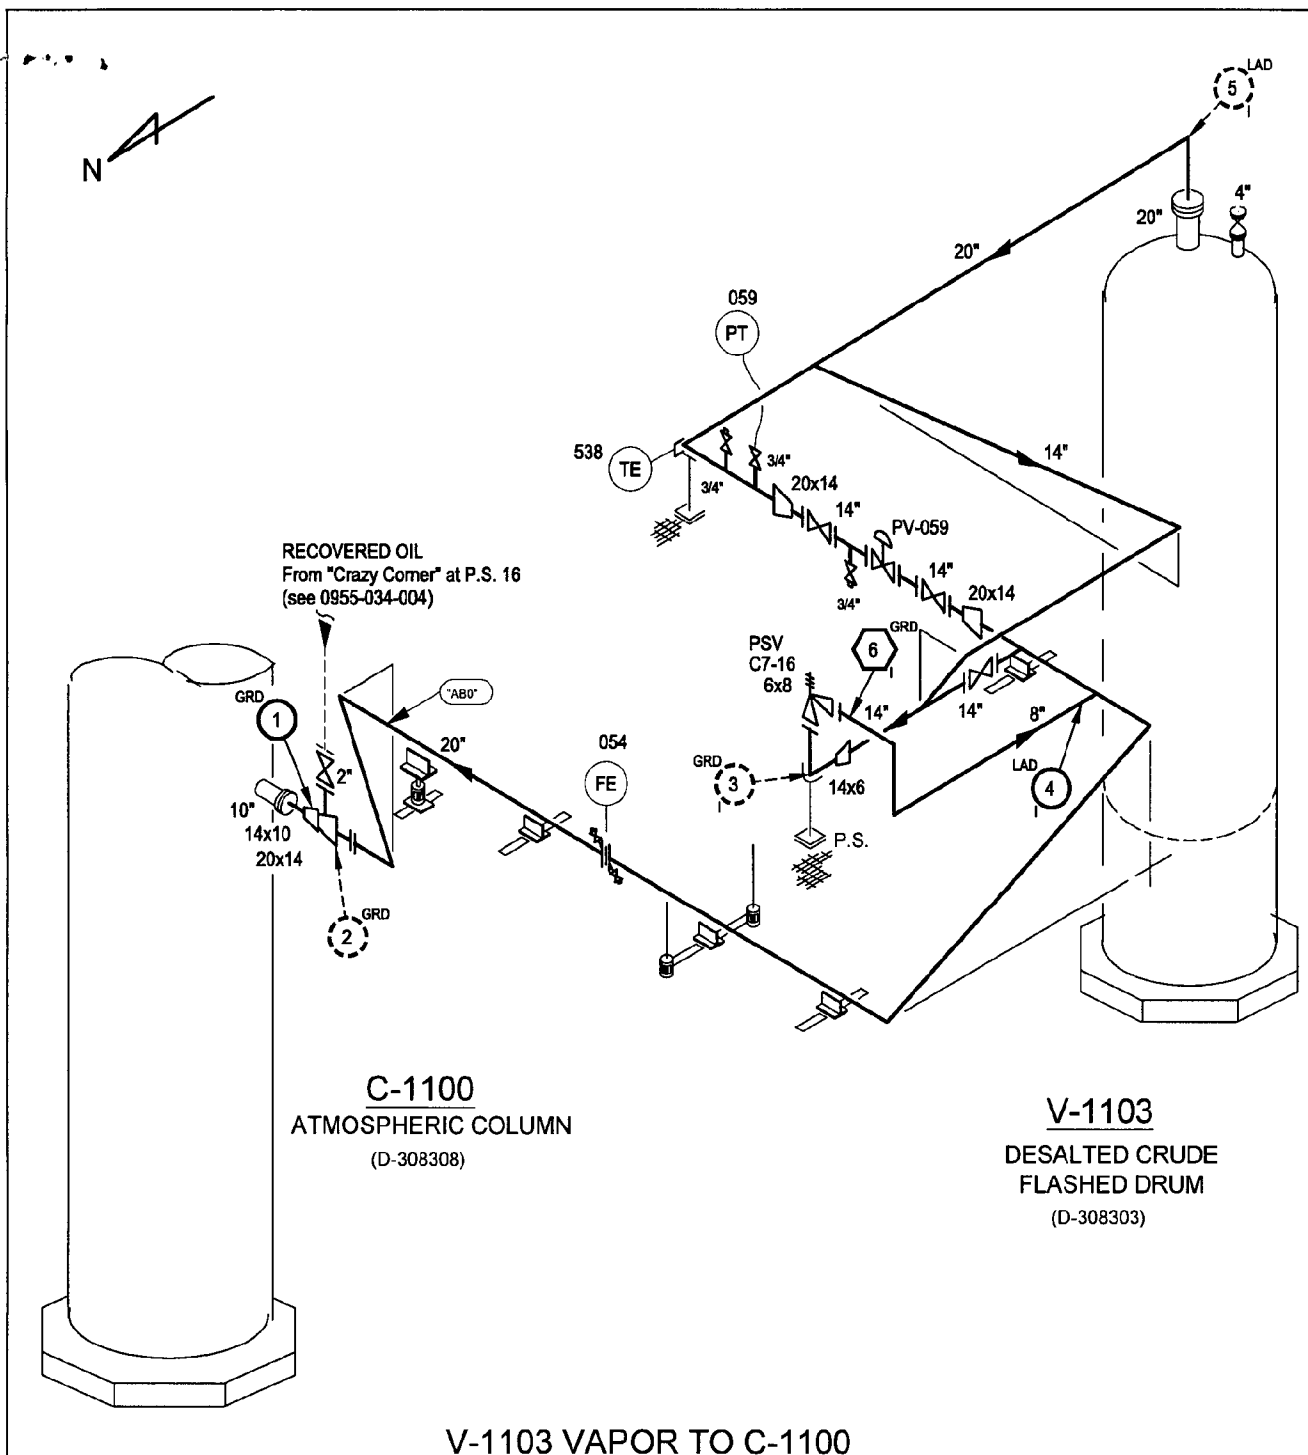
DP ID	MEAS METH	DP STAT	DP SZ	DT TYPE	BASE	MEAS 5	MEAS 4	MEAS 3	NEAR	LAST	MIN VALUE	CCR	REM LIFE
001.B	UT	A	10.00	RED	0.387 08/02					0.400 12/07	0.140	0.00	∞
001.N	UT	A	10.00	RED	0.392 08/02					0.390 12/07	0.140	0.37	673.85
001.S	UT	A	10.00	RED	0.387 08/02					0.390 12/07	0.140	0.00	∞
001.T	UT	A	10.00	RED	0.399 08/02					0.390 12/07	0.140	1.67	149.70
004.E	UT	A	8.00	PIPE	0.386 07/02					0.400 12/07	0.140	0.00	∞
004.J	UT	A	8.00	PIPE	0.392 07/02					0.400 12/07	0.140	0.00	∞
004.W	UT	A	8.00	PIPE	0.407 07/02					0.380 12/07	0.140	4.94	48.60
006.U	UT	A	8.00	PIPE	0.317 08/02					0.310 12/07	0.140	1.30	131.27
